# Microsoft Lumia 535 Loudspeaker ,Vibra Motor or Camera Light Replacement

RM-1090 / RM-1091/ RM-1089 / RM-1092

How to disassemble the phone and replace the Loudspeaker or Vibration motor.

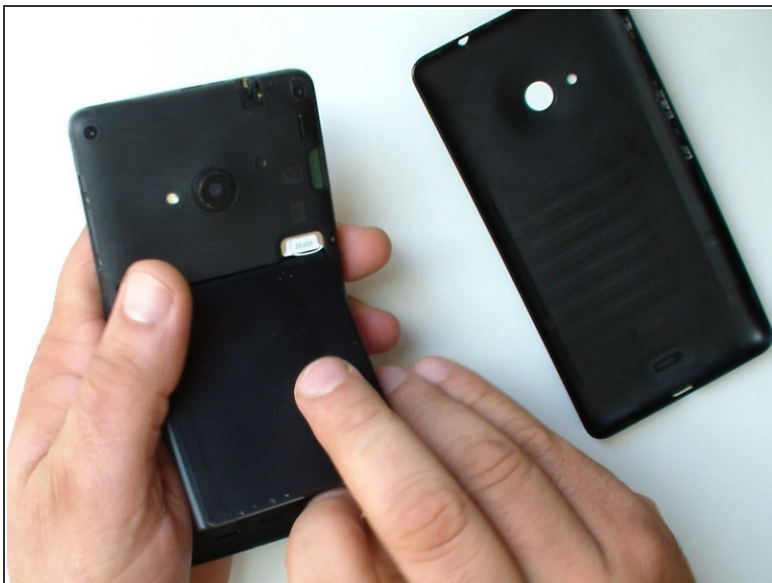
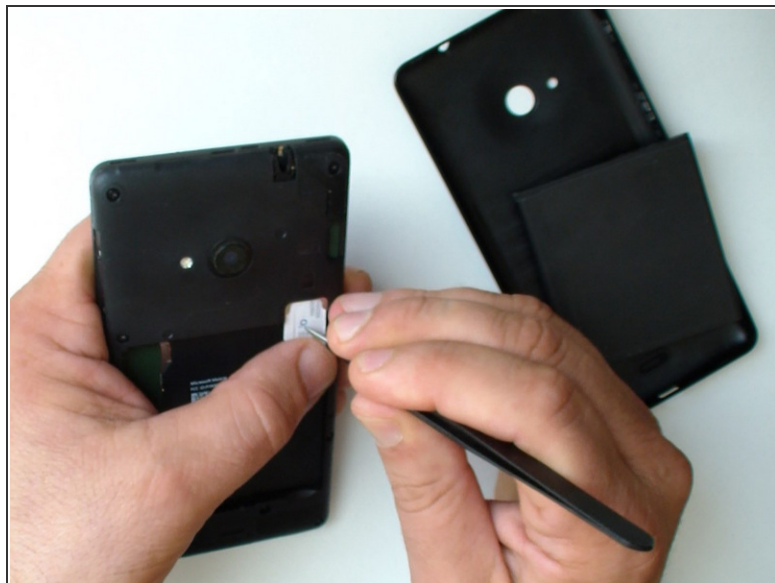
## Step 1 — Back Cover / Rear Case

- Turn off the phone.
- Remove the battery and any SIM and memory cards.

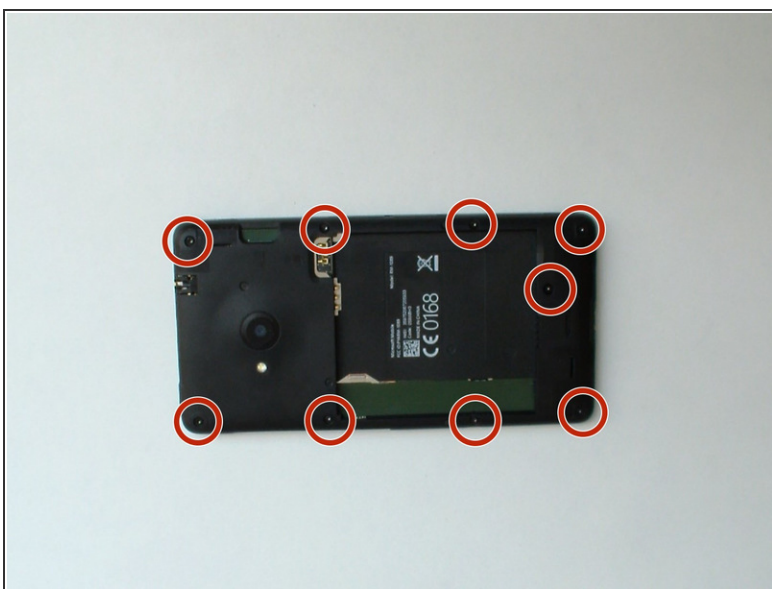
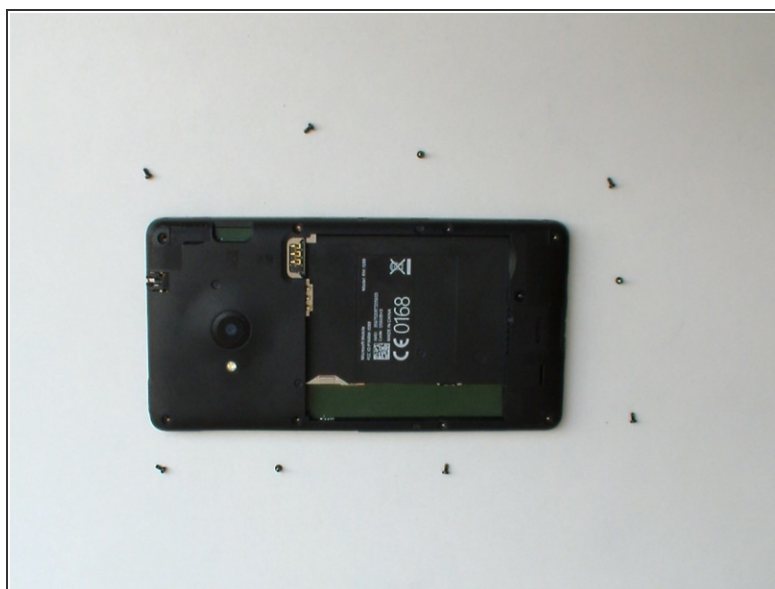
## Step 2

- With a screwdriver Torx T4 remove the 9x screws.

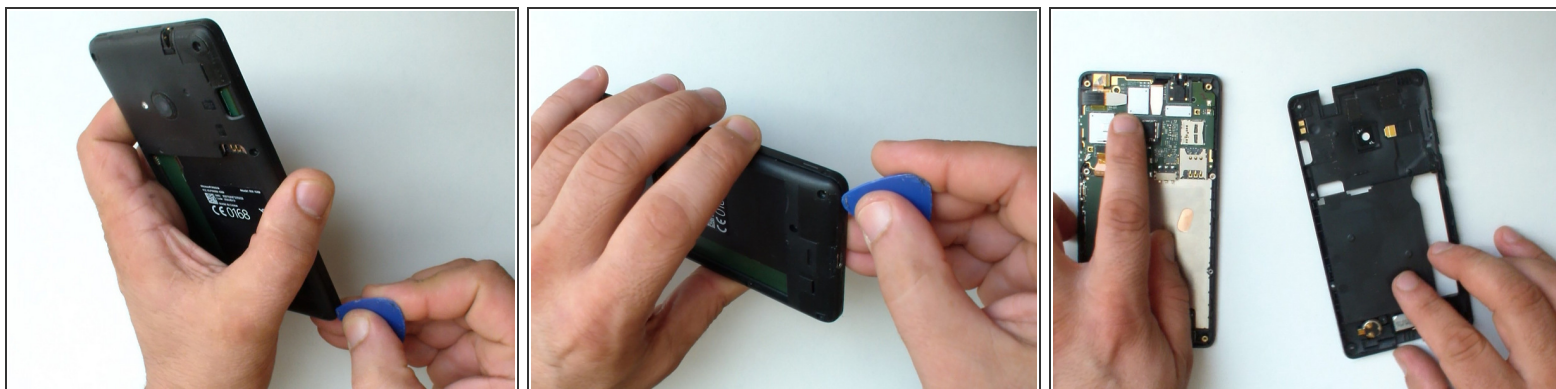
## Step 3

- With a plastic opening tool separate the back cover from the middle frame.

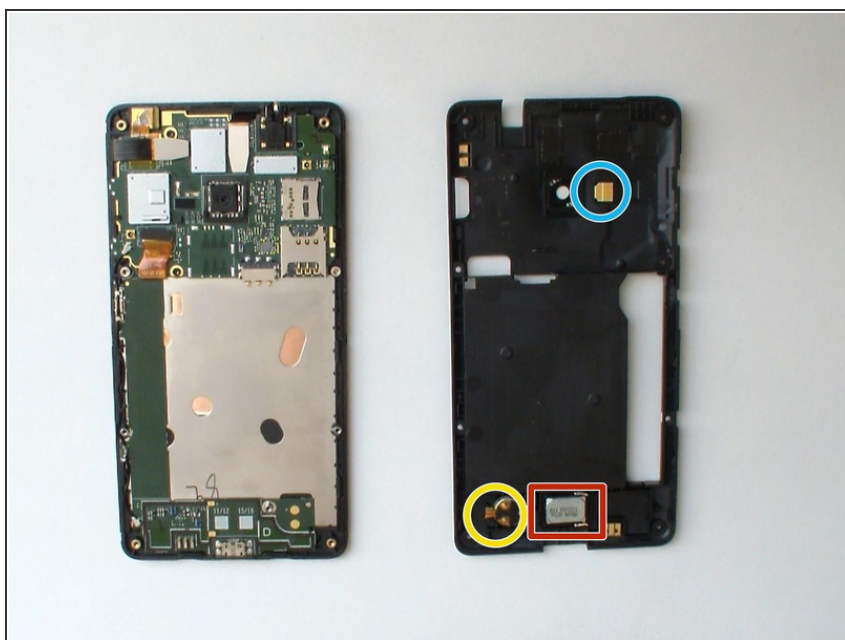
## Step 4 — Loudspeaker and Vibra Motor

- Loudspeaker
- Vibration motor
- Camera light

To reassemble your device, follow these instructions in reverse order.
